A RESOLUTION SEEKING TO APPROVE A CONTRACT BETWEEN THE CITY OF WOOD DALE AND RJN GROUP FOR THE FY 2019 SANITARY SEWER REHABILITATION DESIGN AND CONSTRUCTION OBSERVATION IN THE NOT TO EXCEED AMOUNT OF \$59,880.00

SUBJECT: CITY OF WOOD DALE, IL
PROPOSAL FOR PROFESSIONAL ENGINEERING SERVICES - 2018 MANHOLE
REHABILITATION DESIGN AND CONSTRUCTION OBSERVATION (AREA 3)

SUBJECT: CITY OF WOOD DALE – AREA 2 TELEVISIONING REVIEW AND REHABILITATION PLAN FOR AREAS 2 AND 3 – SUMMARY LETTER AND RECOMMENDATIONS

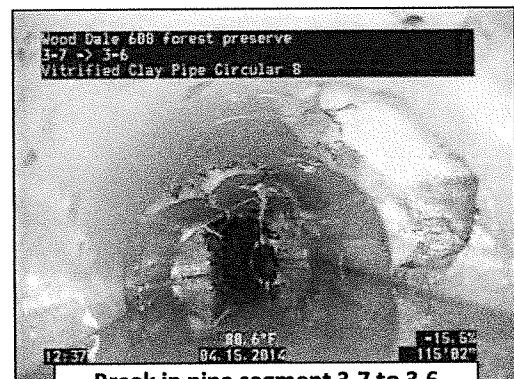
Break in pipe segment 3-7 to 3-6

Closed-circuit television inspection identified several sewer segments containing fractures and breaks that will need rehabilitation. In general, the segments requiring rehabilitation work were made of vitrified clay pipe (VCP). There were three (3) sewer segments that may require a point repair before lining. The remaining defects appear to be good candidates for cured-in-place-pipe (CIPP) lining rehabilitation. Sewer segments with severe structural defects or significant I/I were categorized as high priority. Sewer segments with less severe structural defects and I/I sources were categorized as medium or low priority, depending on condition of the segment. Segments with little or no structural deficiencies were not recommended for CIPP lining. Segments that have been recommended for CIPP with high priority should be rehabilitated before the conditions worsen and point repairs become necessary. Sewer lining is an effective way to rehabilitate a mainline sewer and protect it from structural failure. Table 1 summarizes the findings from CCTV review of Area 2.

It is recommended that the City complete sewer rehabilitation for high priority sewers with a CIPP lining and point repair program. The City should also have CCTV inspection incorporated into the lining and point repair program for any segments that still require inspection. Due to the large quantity of high priority mainline sewer repairs that are needed, the City will not be able to complete all of the high priority repairs within its \$300,000 budget. The cost for high priority rehabilitation in Area 2 is estimated at \$229,510 and the cost for high priority rehabilitation in Area 3 is estimated \$251,745.

It is recommended that the point repairs and lining be completed in Area 2 first, as point repairs are the highest priority and Area 3 does not contain any sewers in need of a point repair. In addition to completing Area 2, the City should try to complete as much rehabilitation work in Area 3 as budget allows, by incorporating an alternate in the CIPP Bid for additional lining. Tables 4 and 5 show the cost estimates for Area 2 and Area 3, respectively. Maps showing the mainline sewer rehabilitation recommendations are given in Appendix A. A detailed list of sewer defects and rehabilitation recommendations from the sewer televising results is presented in Appendix B.

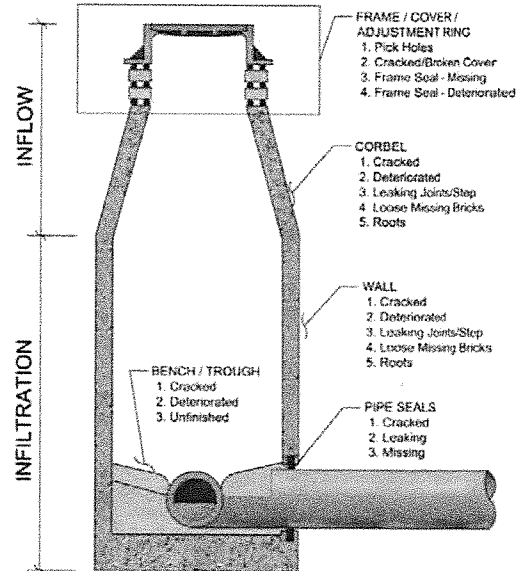
FIGURE 1: MANHOLE DIAGRAM WITH RELATED DEFECTS

Manhole inspection for Area 3 was completed by RJN Group in 2013. Manhole inspection is a method of visually checking the structure condition for indications of I/I. Surface manhole inspections involve assessing all the parts of the structure that are visible from the surface, as shown in Figure 1.

Surface manhole inspections were performed for 118 manholes. Table 3 summarizes the necessary repairs to various manholes within Area 3. This table also provides a cost estimate for the recommended repairs. Appendix C contains a detailed list of rehabilitation recommendations for each manhole.
